FRONTZAHNKRONE | ANTERIOR CROWN

Variante: Standard Charakterisierung | Variant: Standard characterization

SEITENZAHNKRONE | POSTERIOR CROWN

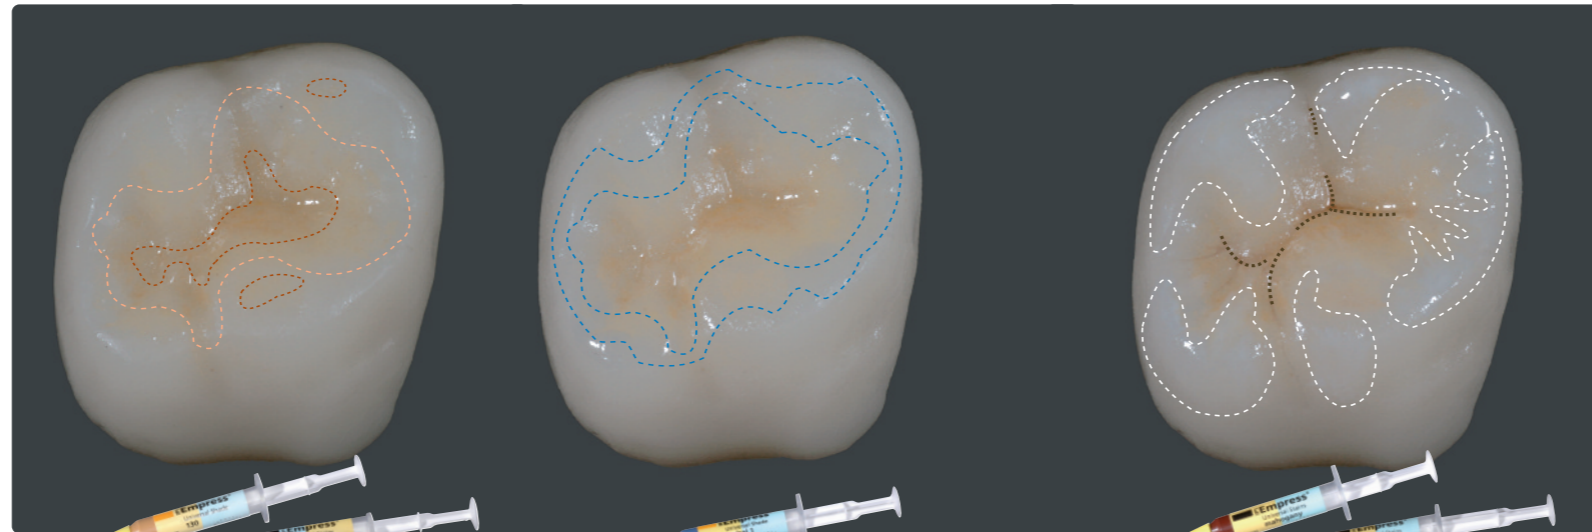
1. Schritt / 1st Step:
Occlusal: Shade 130
Occlusal Fossa: Stains orange

2. Schritt / 2nd Step:
Incisal: Shade I1

3. Schritt und Brennen / 3rd Step and firing:
Fissur / fissure: Stains mahogany
Höcker / cusp: Stains white

B	S	t st	T	H	V ₁	V ₂
403°C	6 min	100°C	790°C	1 min	450°C	789°C
757°F	6 min	180°F	1454°F	1 min	842°F	1453°F
